DEPARTMENT OF THE ARMY  
NEW ENGLAND DISTRICT  
CORPS OF ENGINEERS  
CONCORD, MASSACHUSETTS

INVESTIGATION OF LYMANSVILLE AND MANTON DAMS  
WOONASQUATUCKET RIVER, RHODE ISLAND

MAY, 2005

LYMANSVILLE AND MANTON DAMS  
WOONASQUATUCKET RIVER, RHODE ISLAND

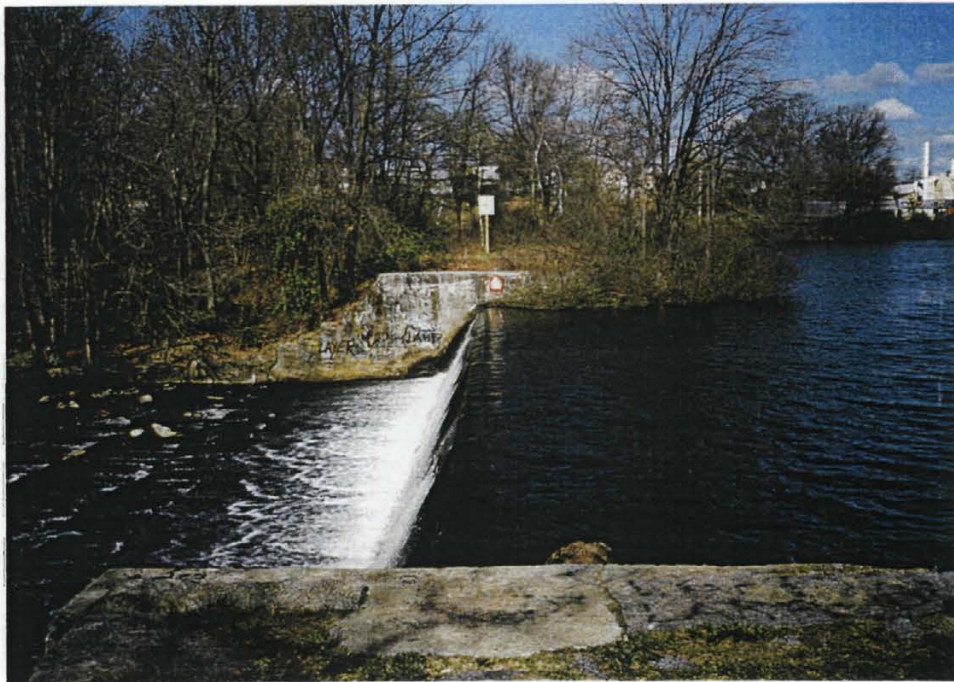
Photo 3: West abutment wall and the spillway crest. Note: the rapid flow of water over the spillway and the graffiti on the west abutment wall.

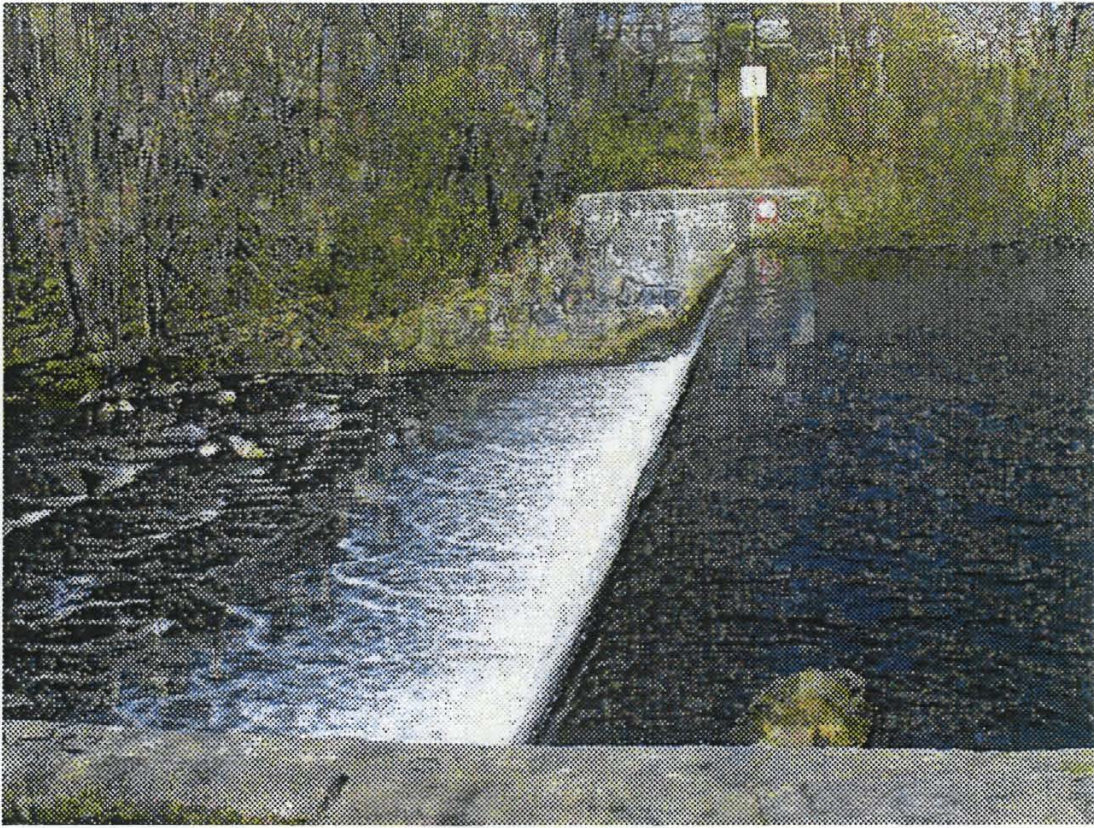
Photo 1 – Overview of spillway from left wing wall.

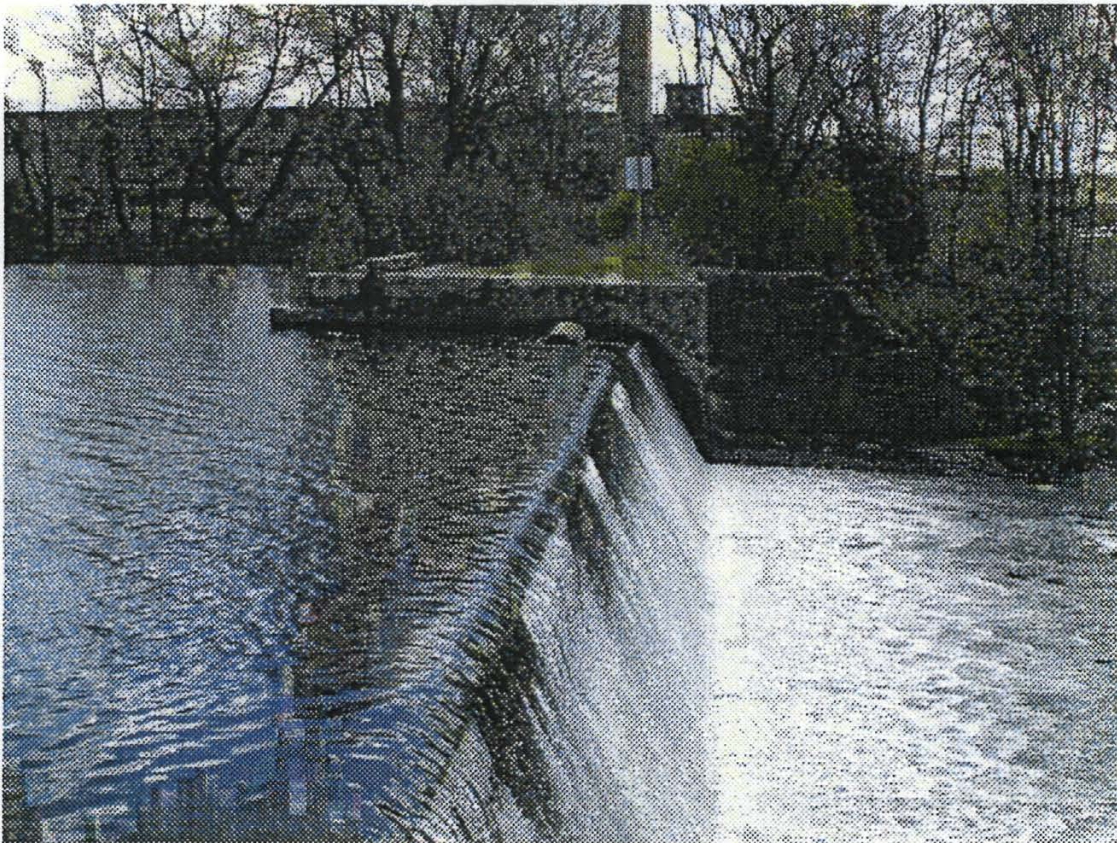
Photo 2 – Overview of spillway from right wing wall.

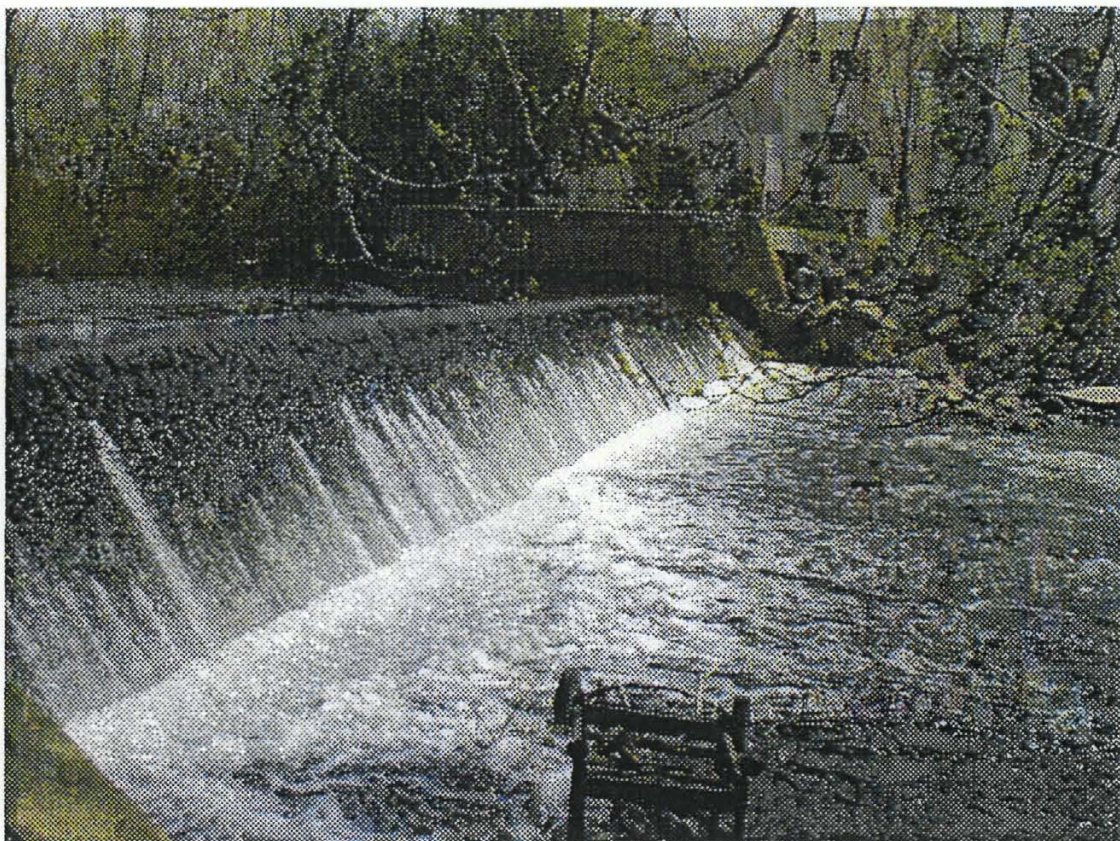
Photo 3 – Spillway from base of right embankment

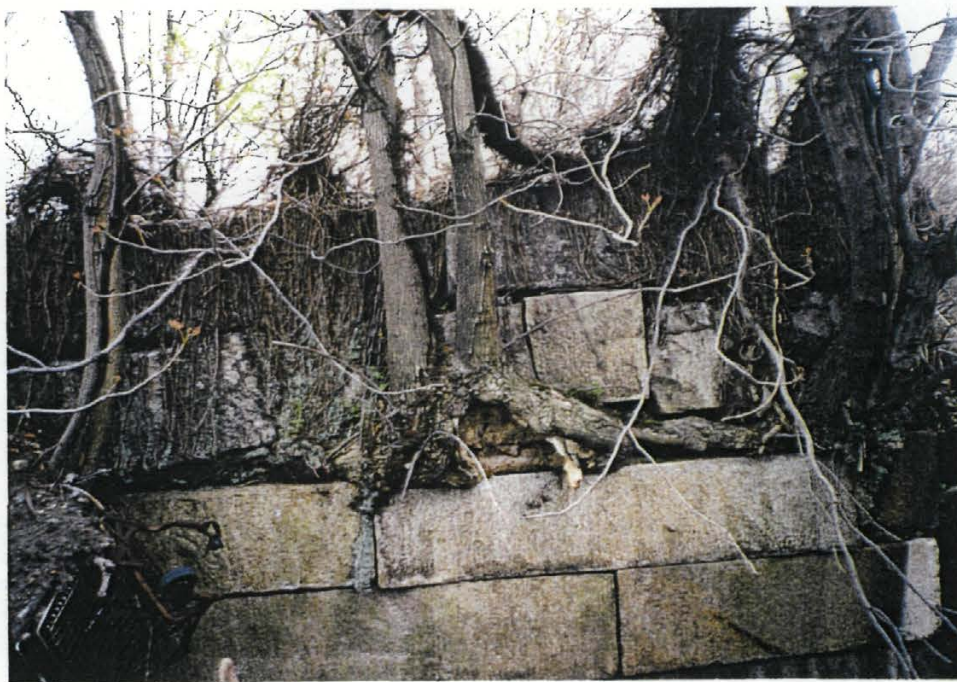
Photo 2: The large stone blocks making up the outlet structure have shifted and moved, up to 4", due to the growth of trees between the joints.

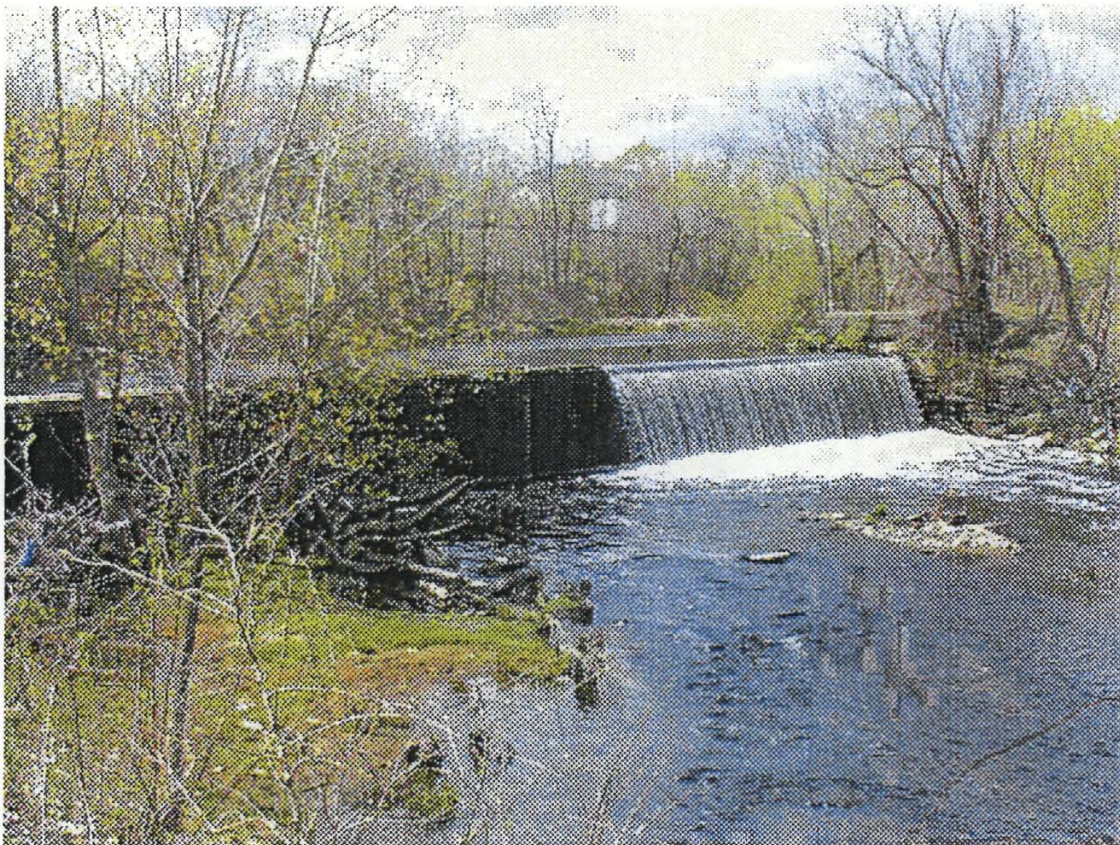
Photo 1 – Overview of dam.

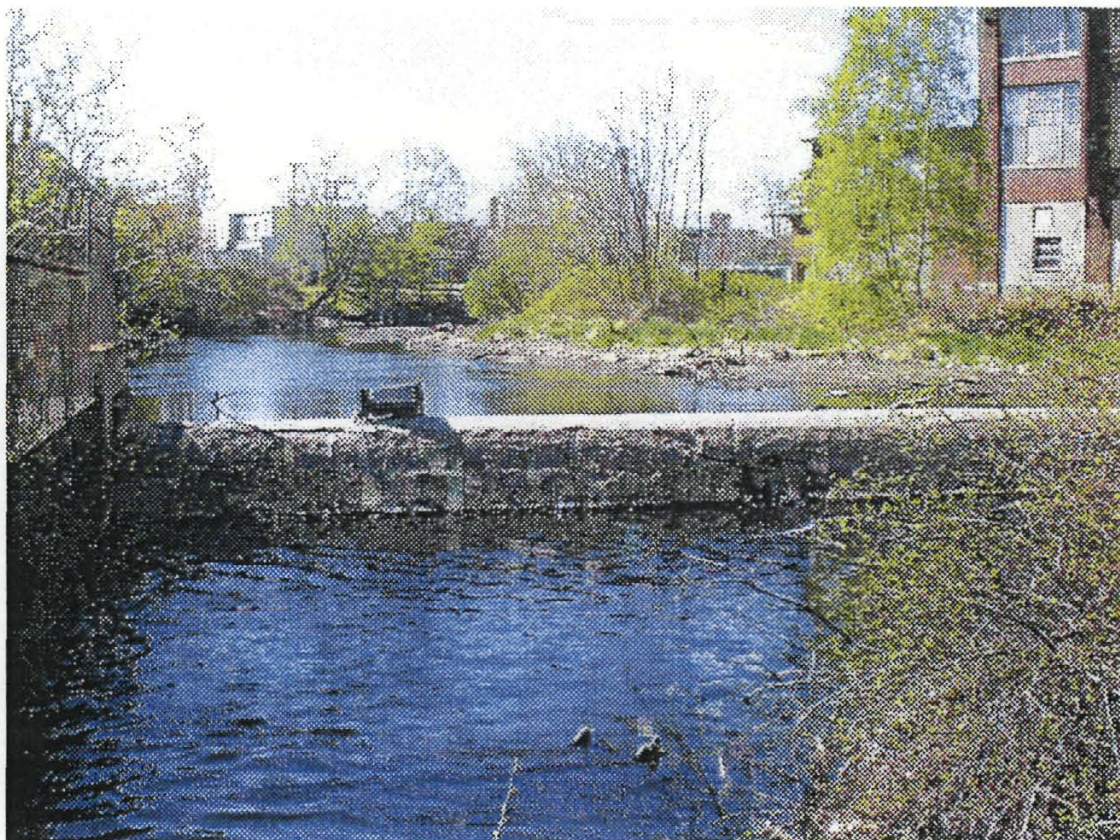
Photo 1 – Overview of dam.

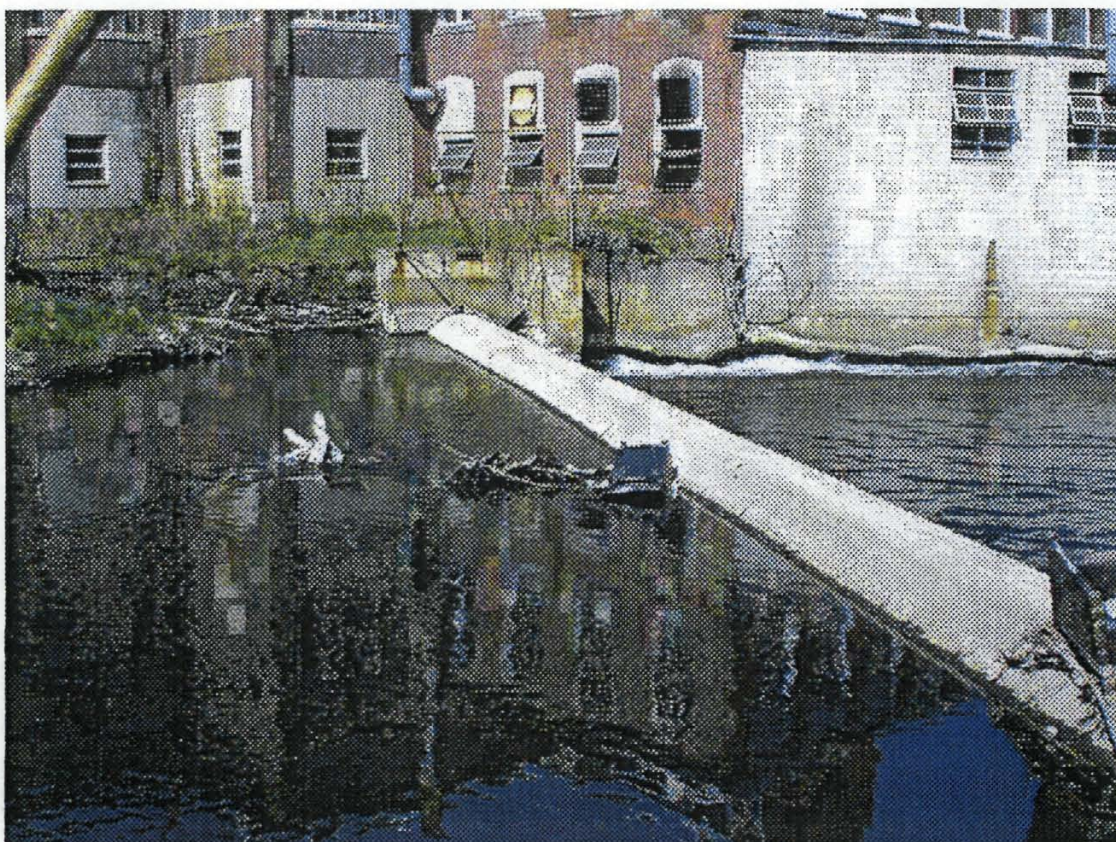
Photo 2 – Overview of dam.

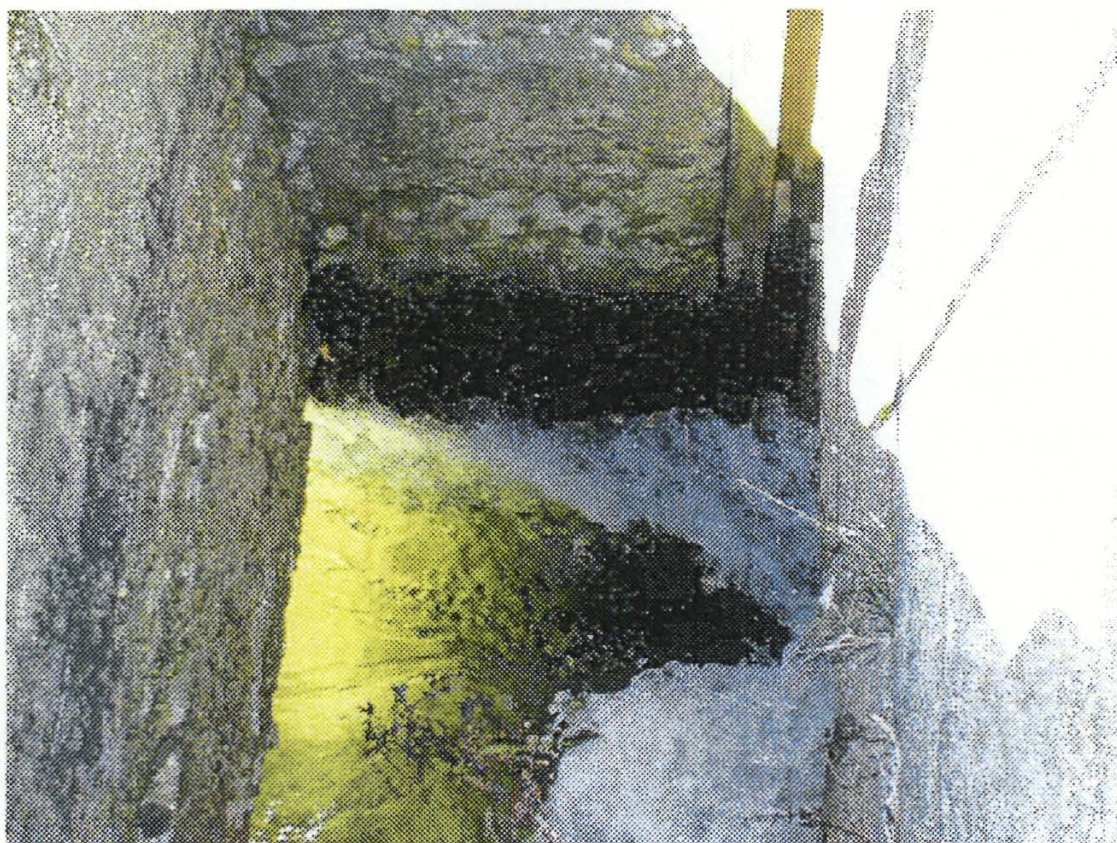
Photo 6 – Inside outlet works on left side of spillway.

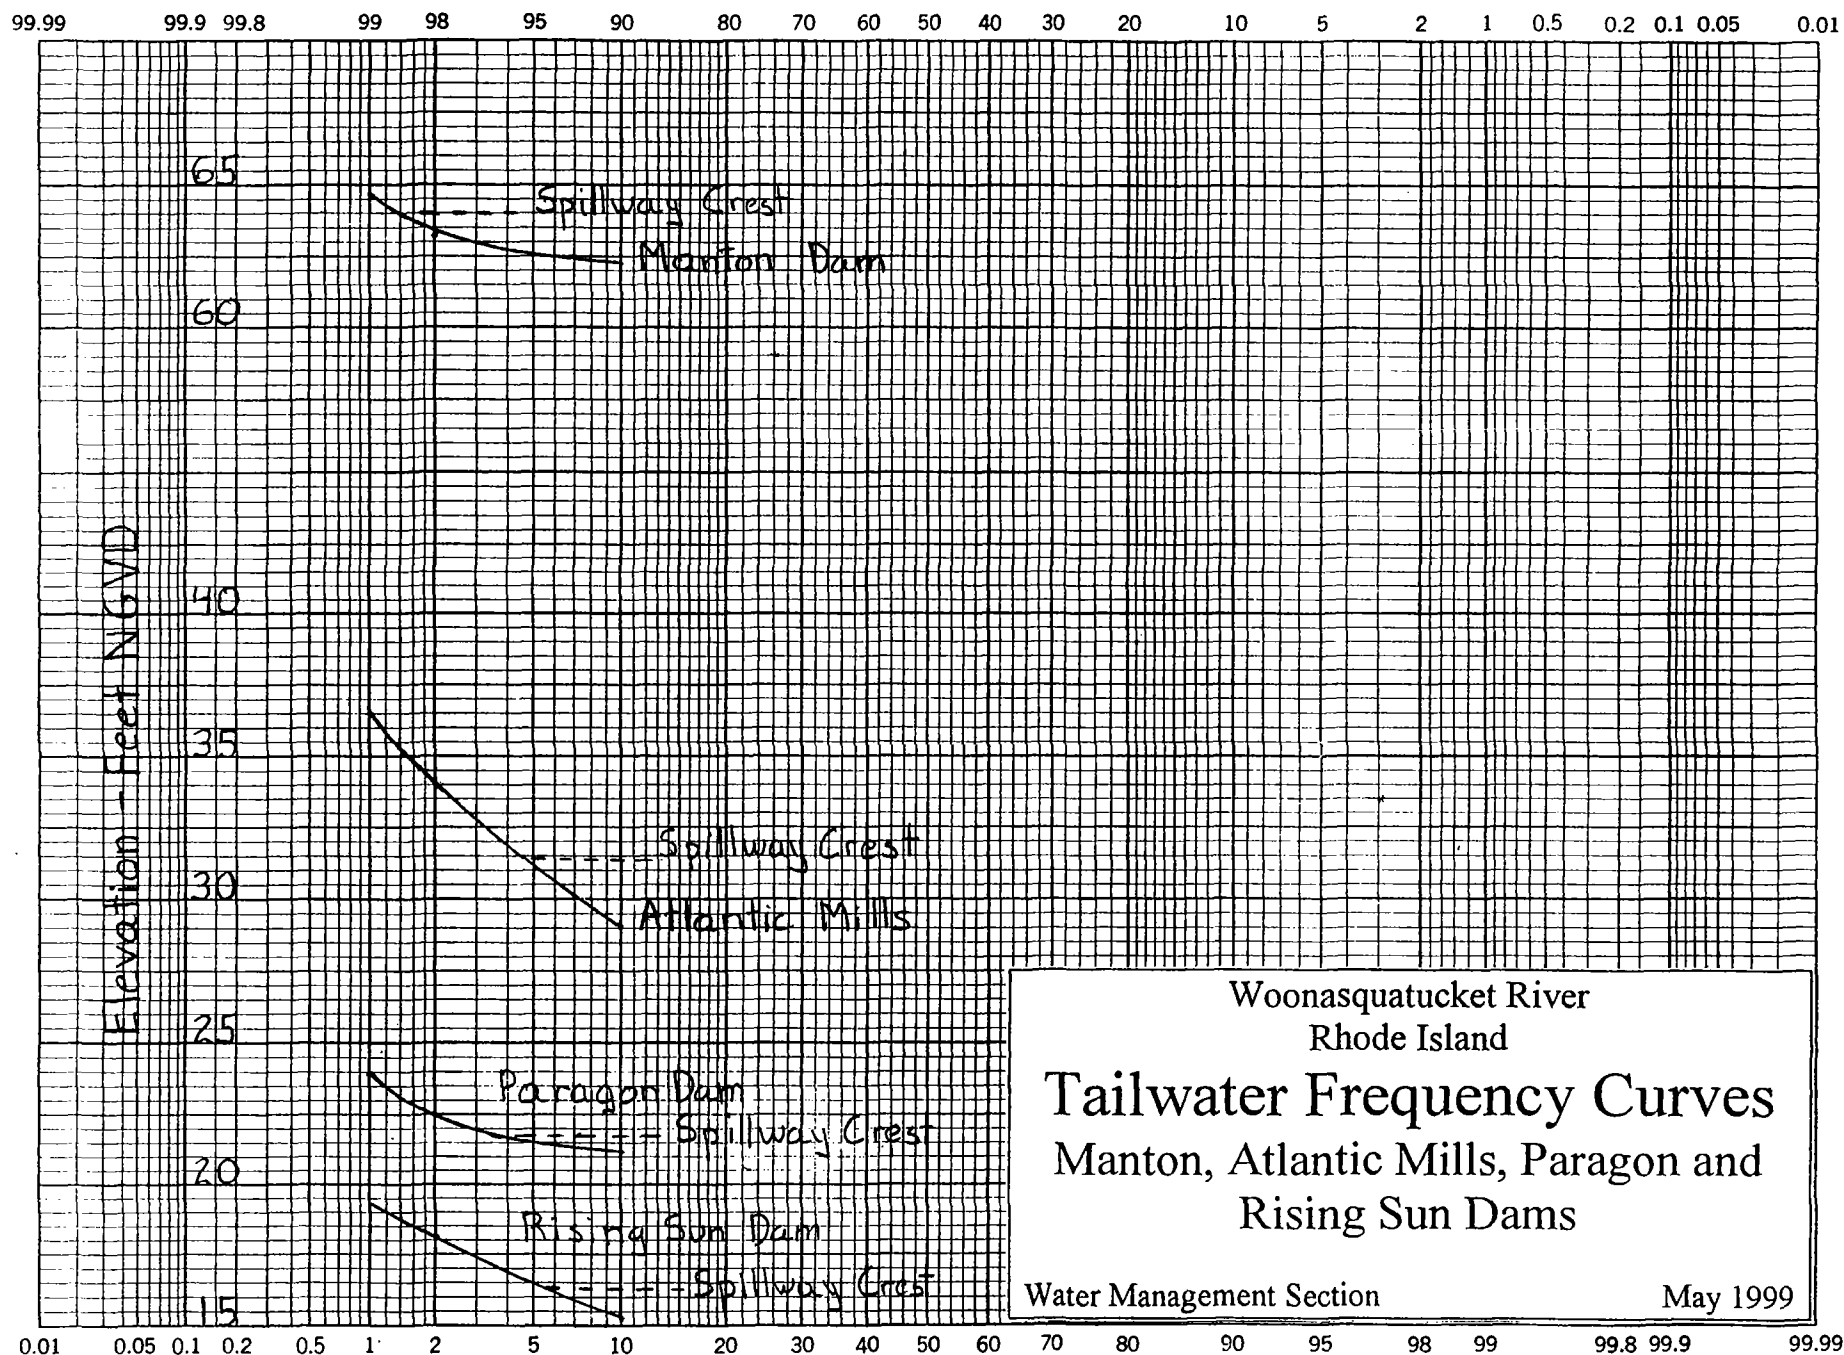
Figure 2

4. Elevations. Spillway crest elevation of 21.8 feet, NGVD was taken from the Battelle report. Top of dam elevation of 25.8 was taken from the elevation of the top of concrete outlet works Battelle report. By comparison, a spillway crest elevation of 21.6 was estimated from a flood profile in the PFIS. The top of dam elevation of 25.6 feet was estimated by adding the 4-foot height above spillway crest in the WPA drawing to the crest elevation of 21.6 feet. These numbers are very close to survey results in the Battelle report.

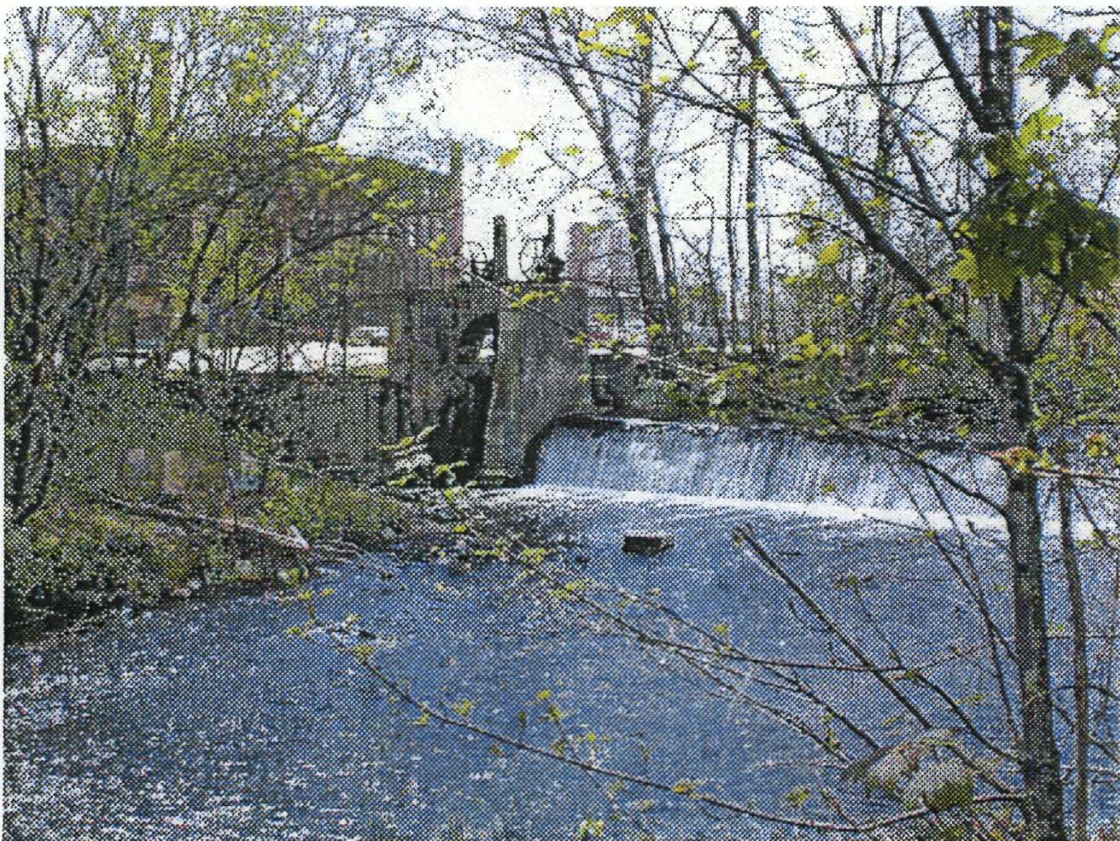
Photo 2 – Overview of dam from left bank.

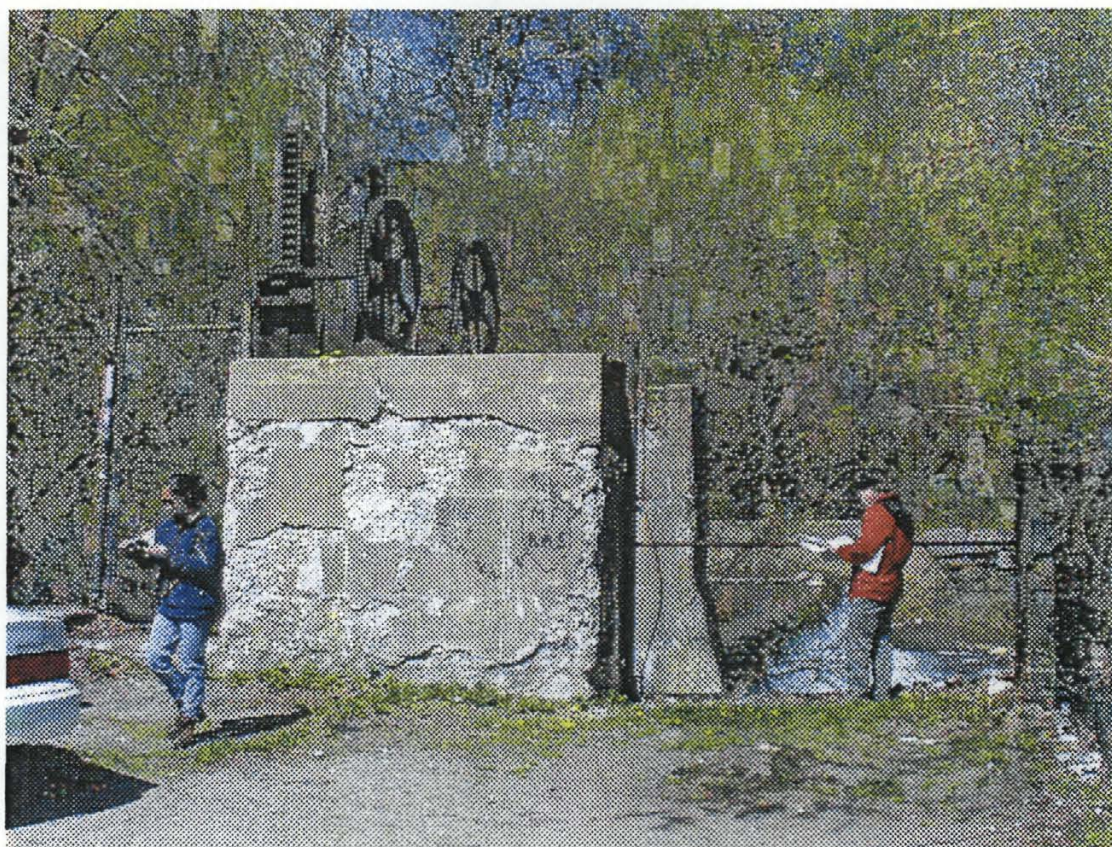
Photo 3 – Outlet works on right bank.

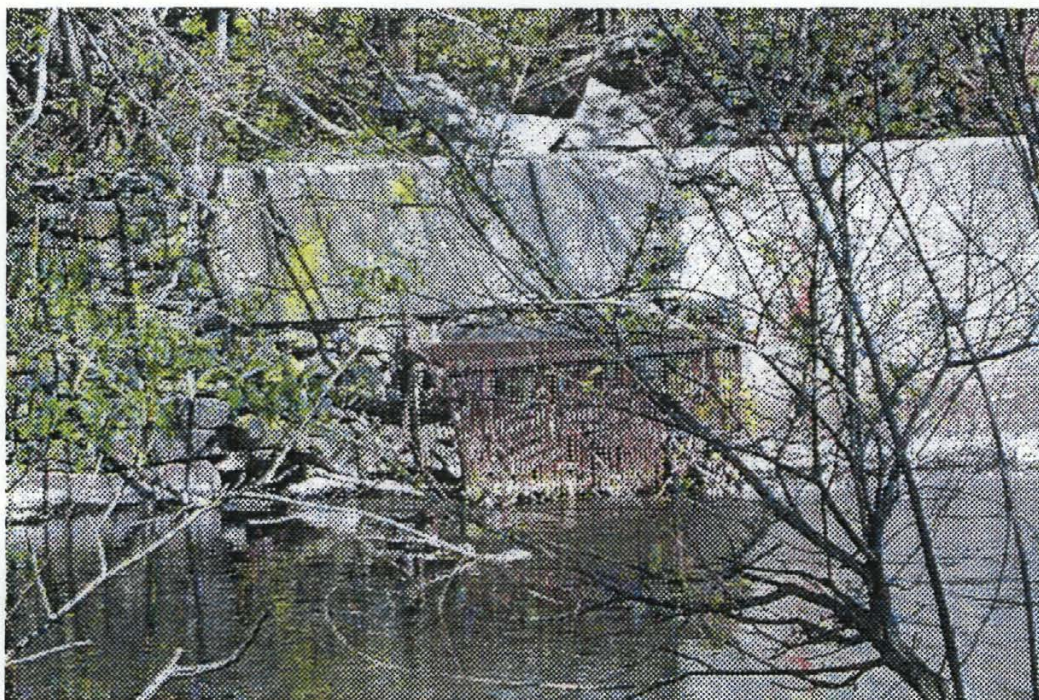
Photo 6 – Trash rack at old water supply intake on left side of dam.

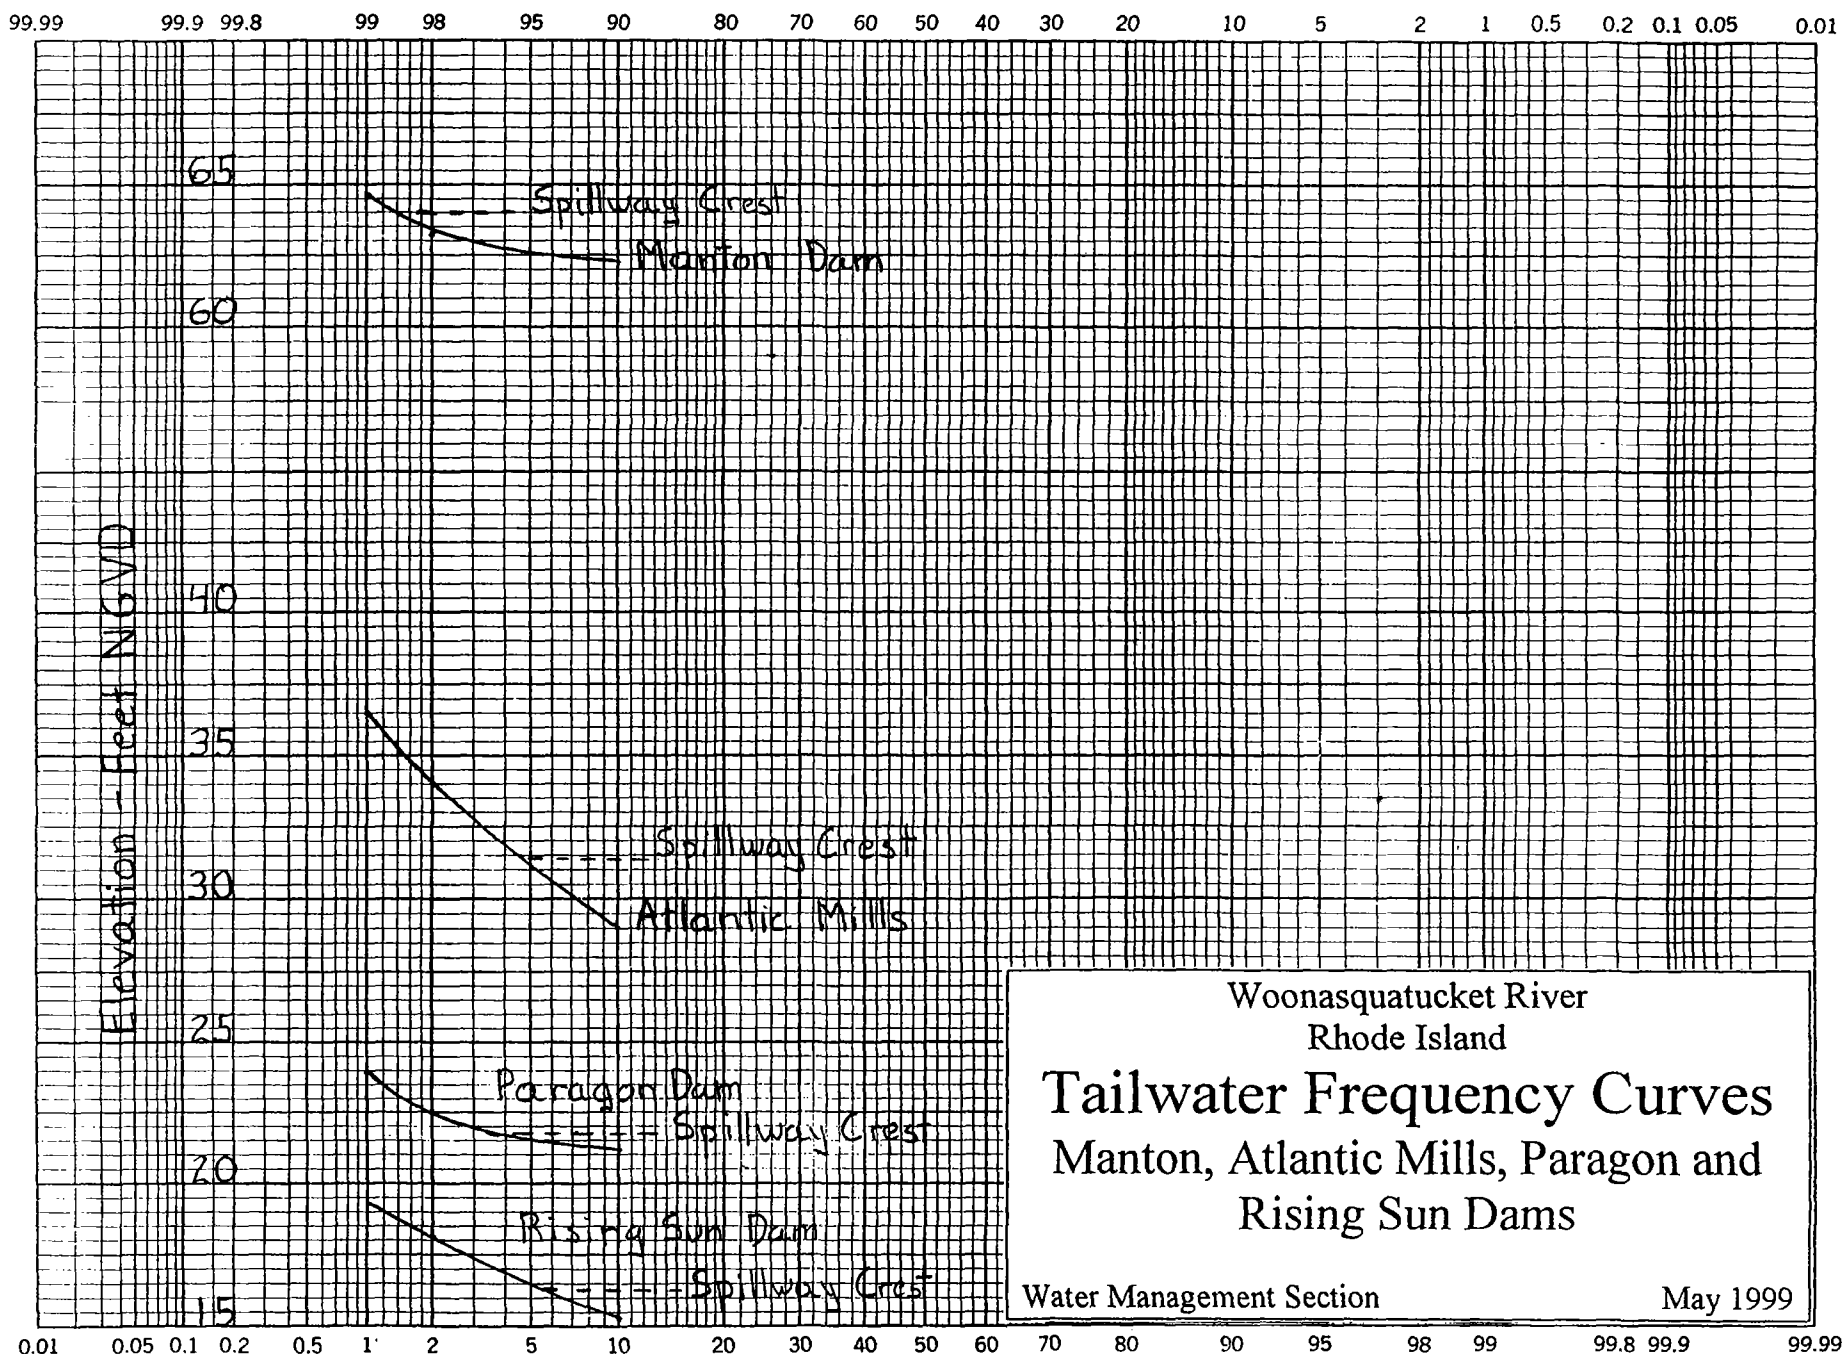
Figure 2

3. Flows. Estimated peak flood discharges at the Rising Sun Dam and water surface elevations were taken from the PFIS and are given in table 2. Tailwater elevations were plotted on probability paper, and this plot was used to interpolate the frequency of the tailwater that would reach spillway crest elevation (figure 2).
