Appendix D
Construction Program Site Visit Reports

Thomes Creek Bridge Project
Site Visit Date: 10/13/2009

**Caltrans MS4 (SWRCB Order No. 99-06-DWQ)
Thomes Creek Bridge Project
Caltrans District 2**

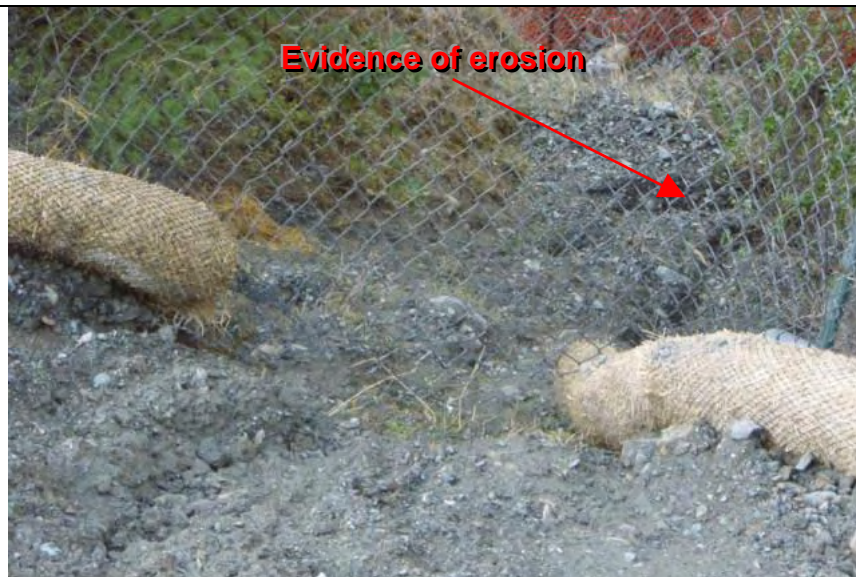
Photograph 8 – Closer view of straw wattle and erosion pictured in Photograph 7

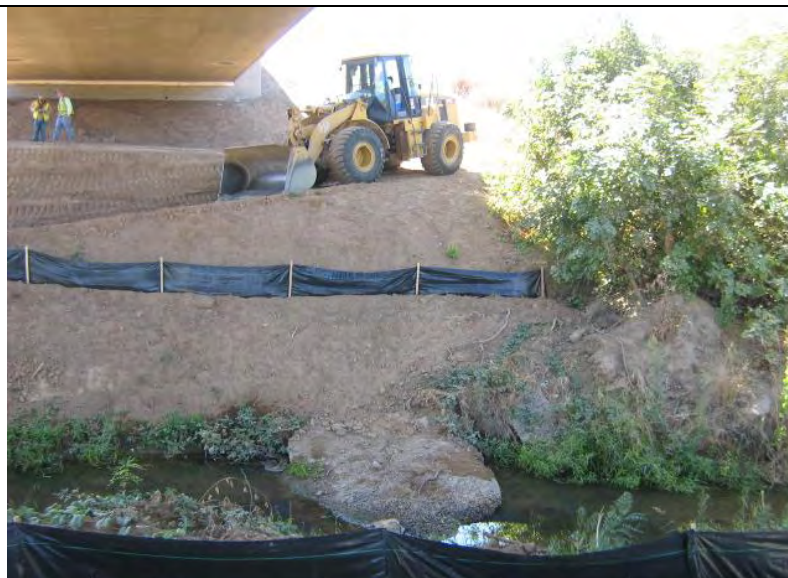
Photograph 20 – Differing vantage point for Photograph 19

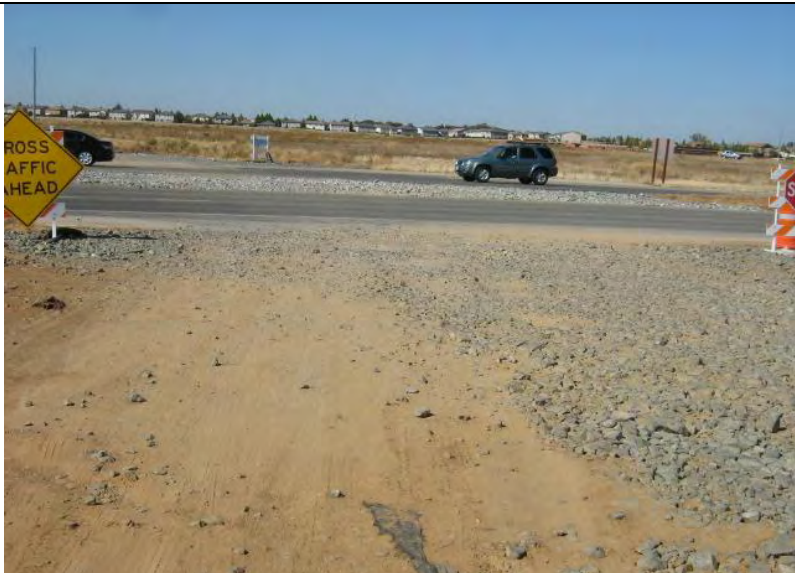
Photograph 5 – Vehicle tracking pad BMP not adequately maintained (e.g., sediment in pad, and rock thin and sparse in areas)

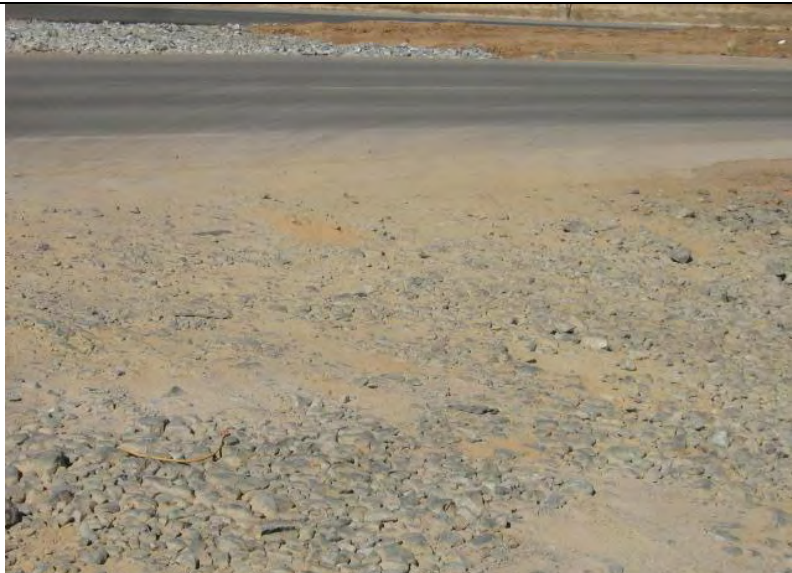
Photograph 6 – Close-up of Photograph 5 depicting sediment in VTC pad, and rock which was thin, sparse and compacted in areas

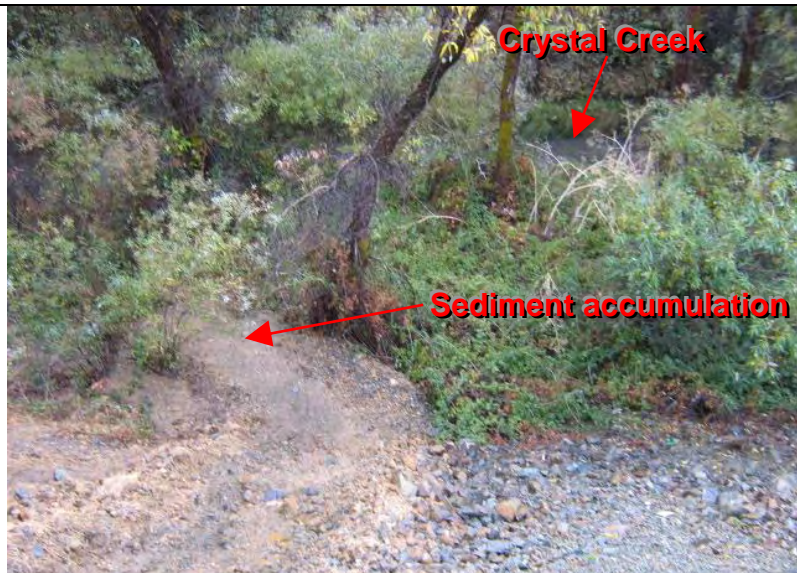
Photograph 5—Discharge of sediment and sediment accumulation in Crystal Creek

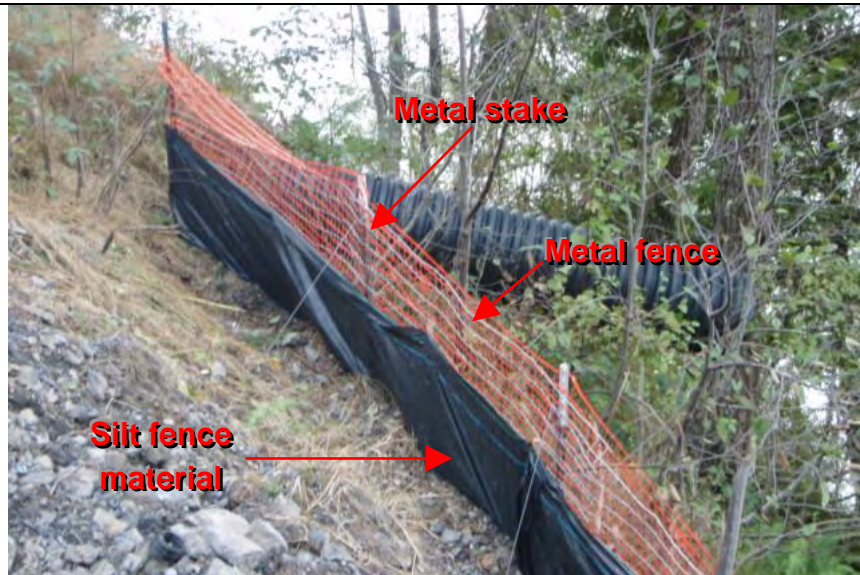
Photograph 1 – Example of reinforced silt fence BMP

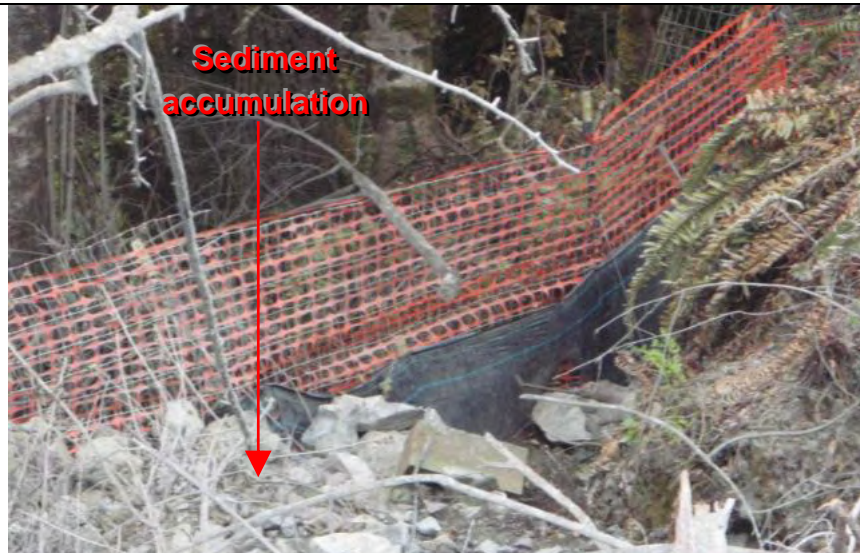
Photograph 3 – Example of sediment accumulation against silt fence BMP

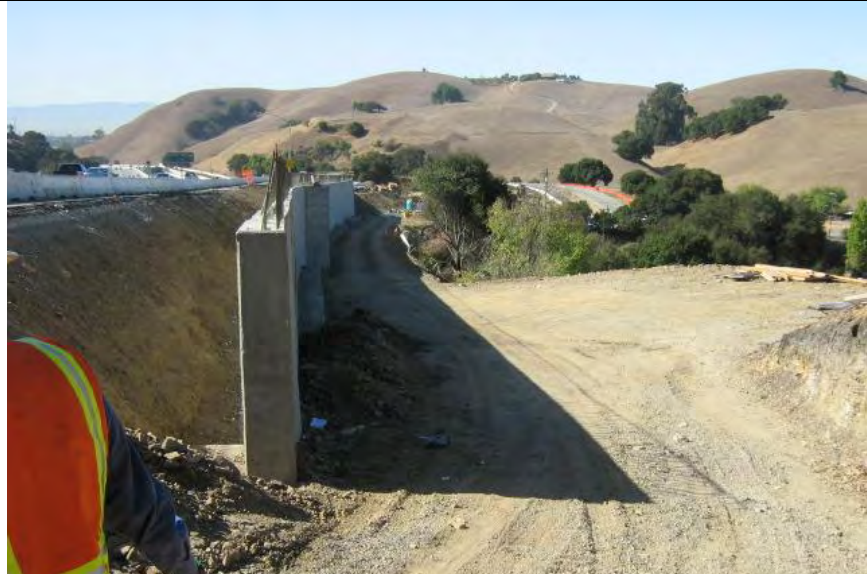
Photograph 1 – View down-gradient along access road
