Appendix E

Maintenance Program Site Visit Reports

Site Visit No. 16

Willow Creek Highway Maintenance Facility
Site Visit Date: 10/22/2009

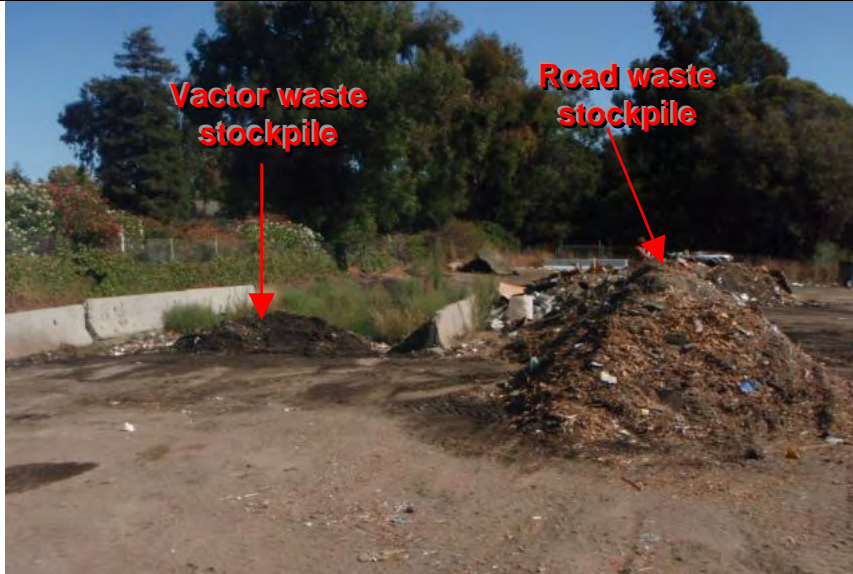
Photograph 1 –Waste stockpiles at the facility

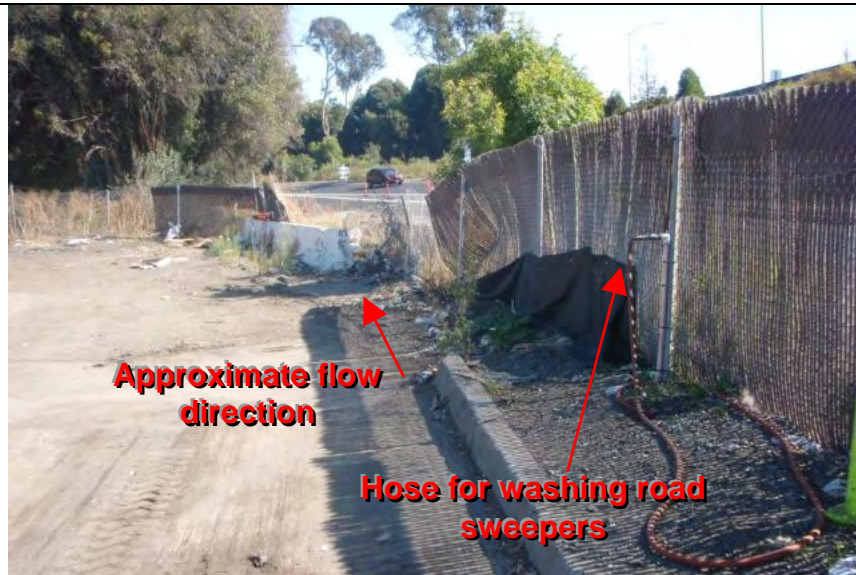
Photograph 6 – Location of road sweeper pre-washing area

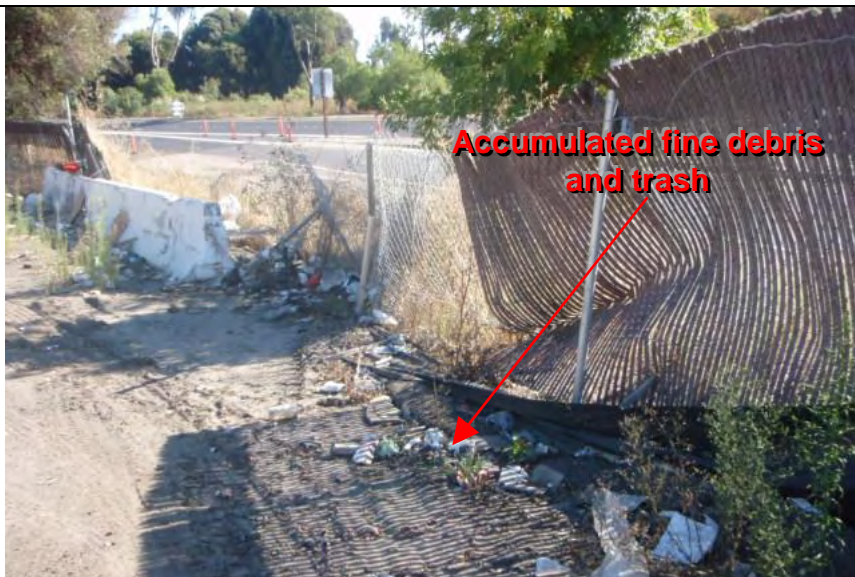
Photograph 7 – View of site boundary down-gradient of road sweeper pre-washing area

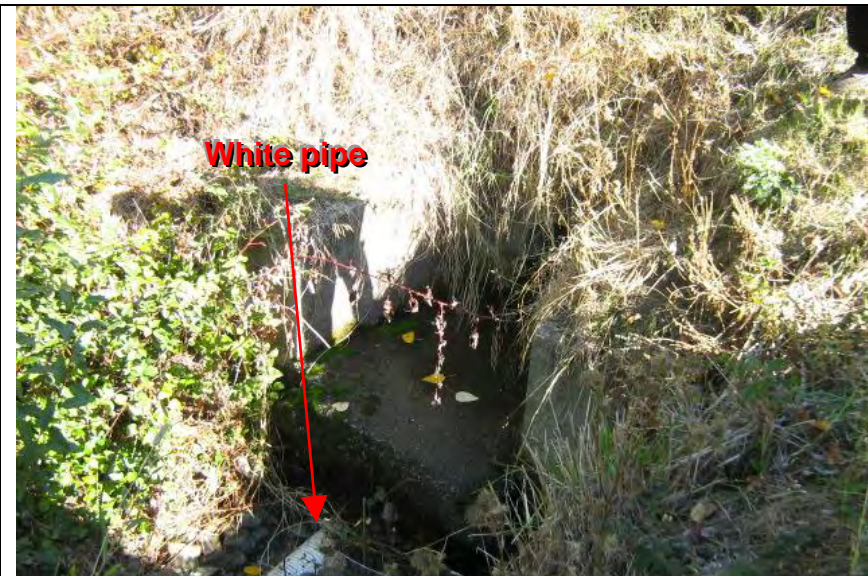
Photograph 10 – Facility outfall

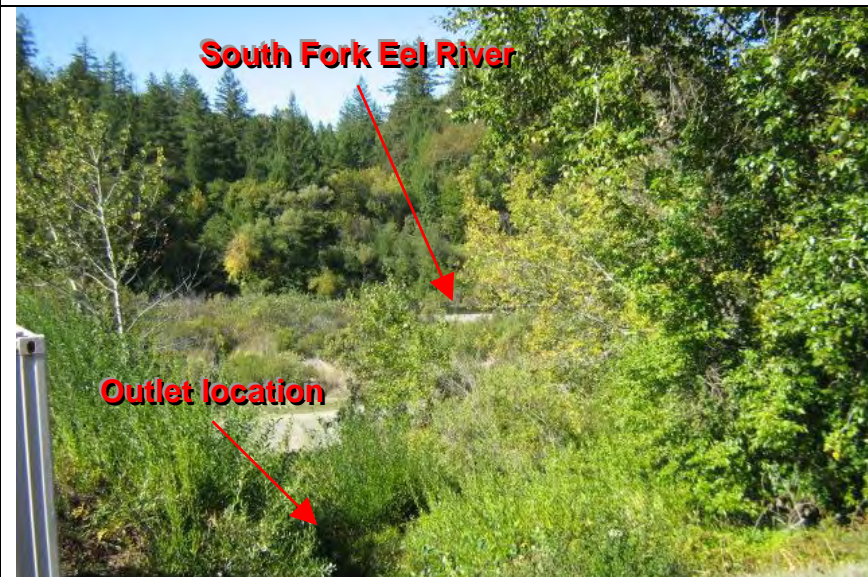
Photograph 12— Proximity of outlet to receiving water

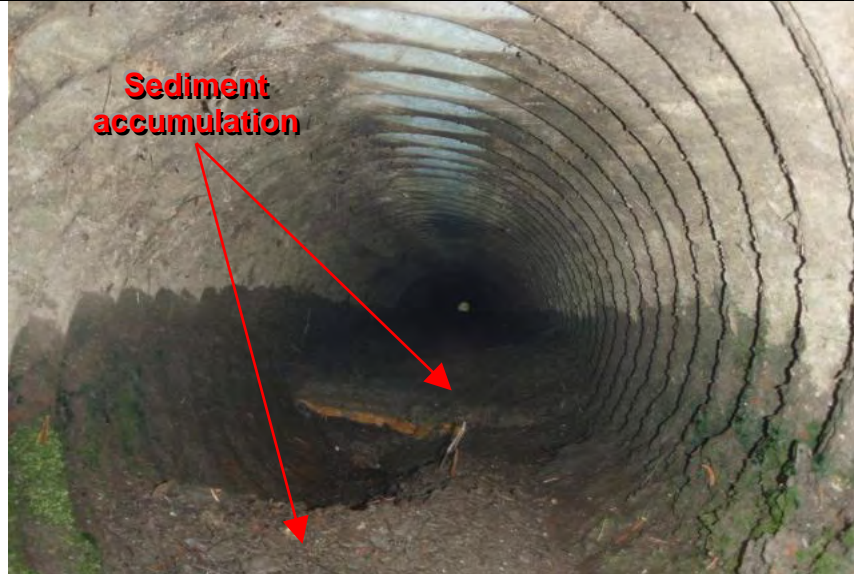
Photograph 5— View into storm drain pipe from outlet

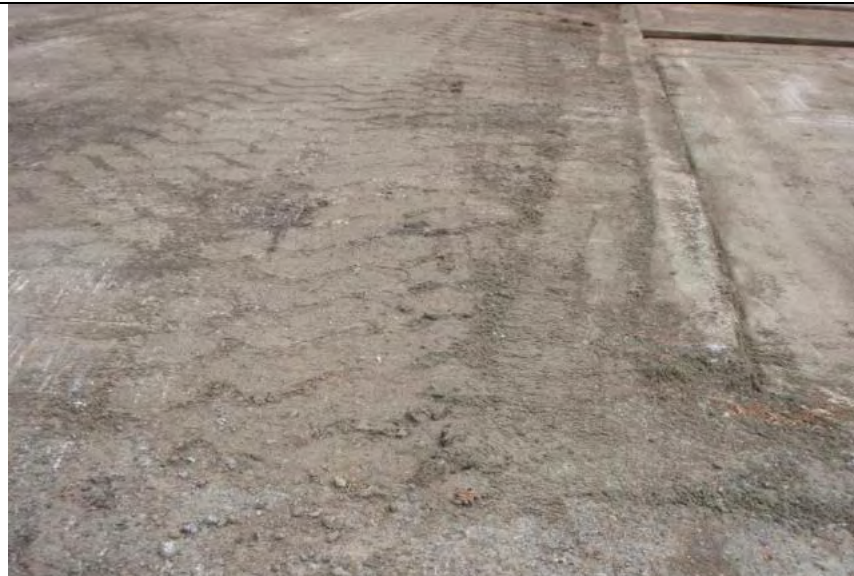
In addition, a significant amount of sediment accumulation was observed on the impervious ground surface near the southeast corner of the facility (see Photographs 6 and 7). As explained by the Highway Maintenance Supervisor, the area was used as a temporary stockpile location for washout material from front loaders and dump trucks. Whether the equipment washout operation was conducted with dry or wet processes was unclear. Appendix D of the Caltrans SWMP, Section 2.15.1, Vehicle and Equipment Cleaning, states “when possible, truck beds should be cleaned using dry cleanup technique (sweep up or shovel out).” It should also be noted that the stockpile area was located directly in the flow pathway of the surface drainage system at the facility (see Photograph 8). As a result, there was a potential for the discharge of sediment and other pollutants to the drainage ditch along the southern edge of the facility (see Photograph 9).

Photograph 7— Closer view of sediment accumulation on imperious
ground surface

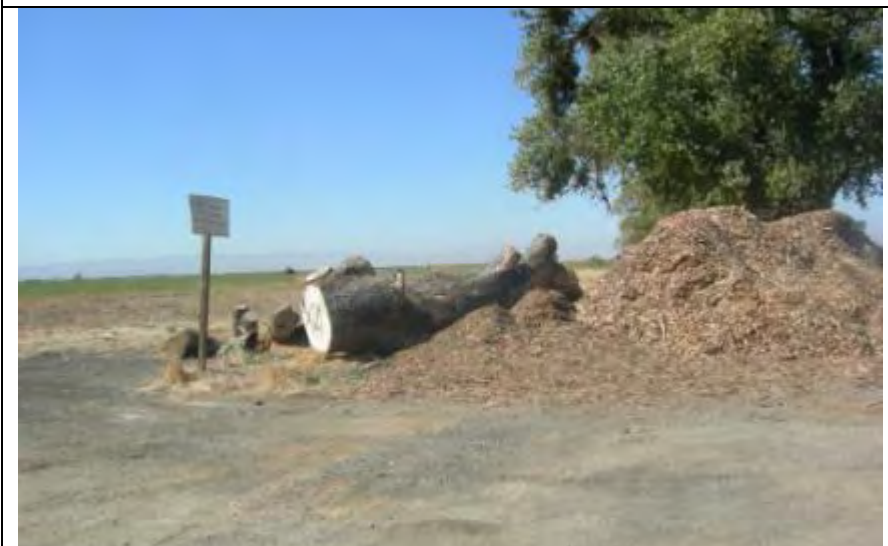
Photograph 3 – View of tree trimming debris
